Inspector's Daily Report

IDR Sheet	1	of	1	Sheets	Final Record Book	Page			
Contract	C-7852			Day	Thursday		Date	August 11, 2011

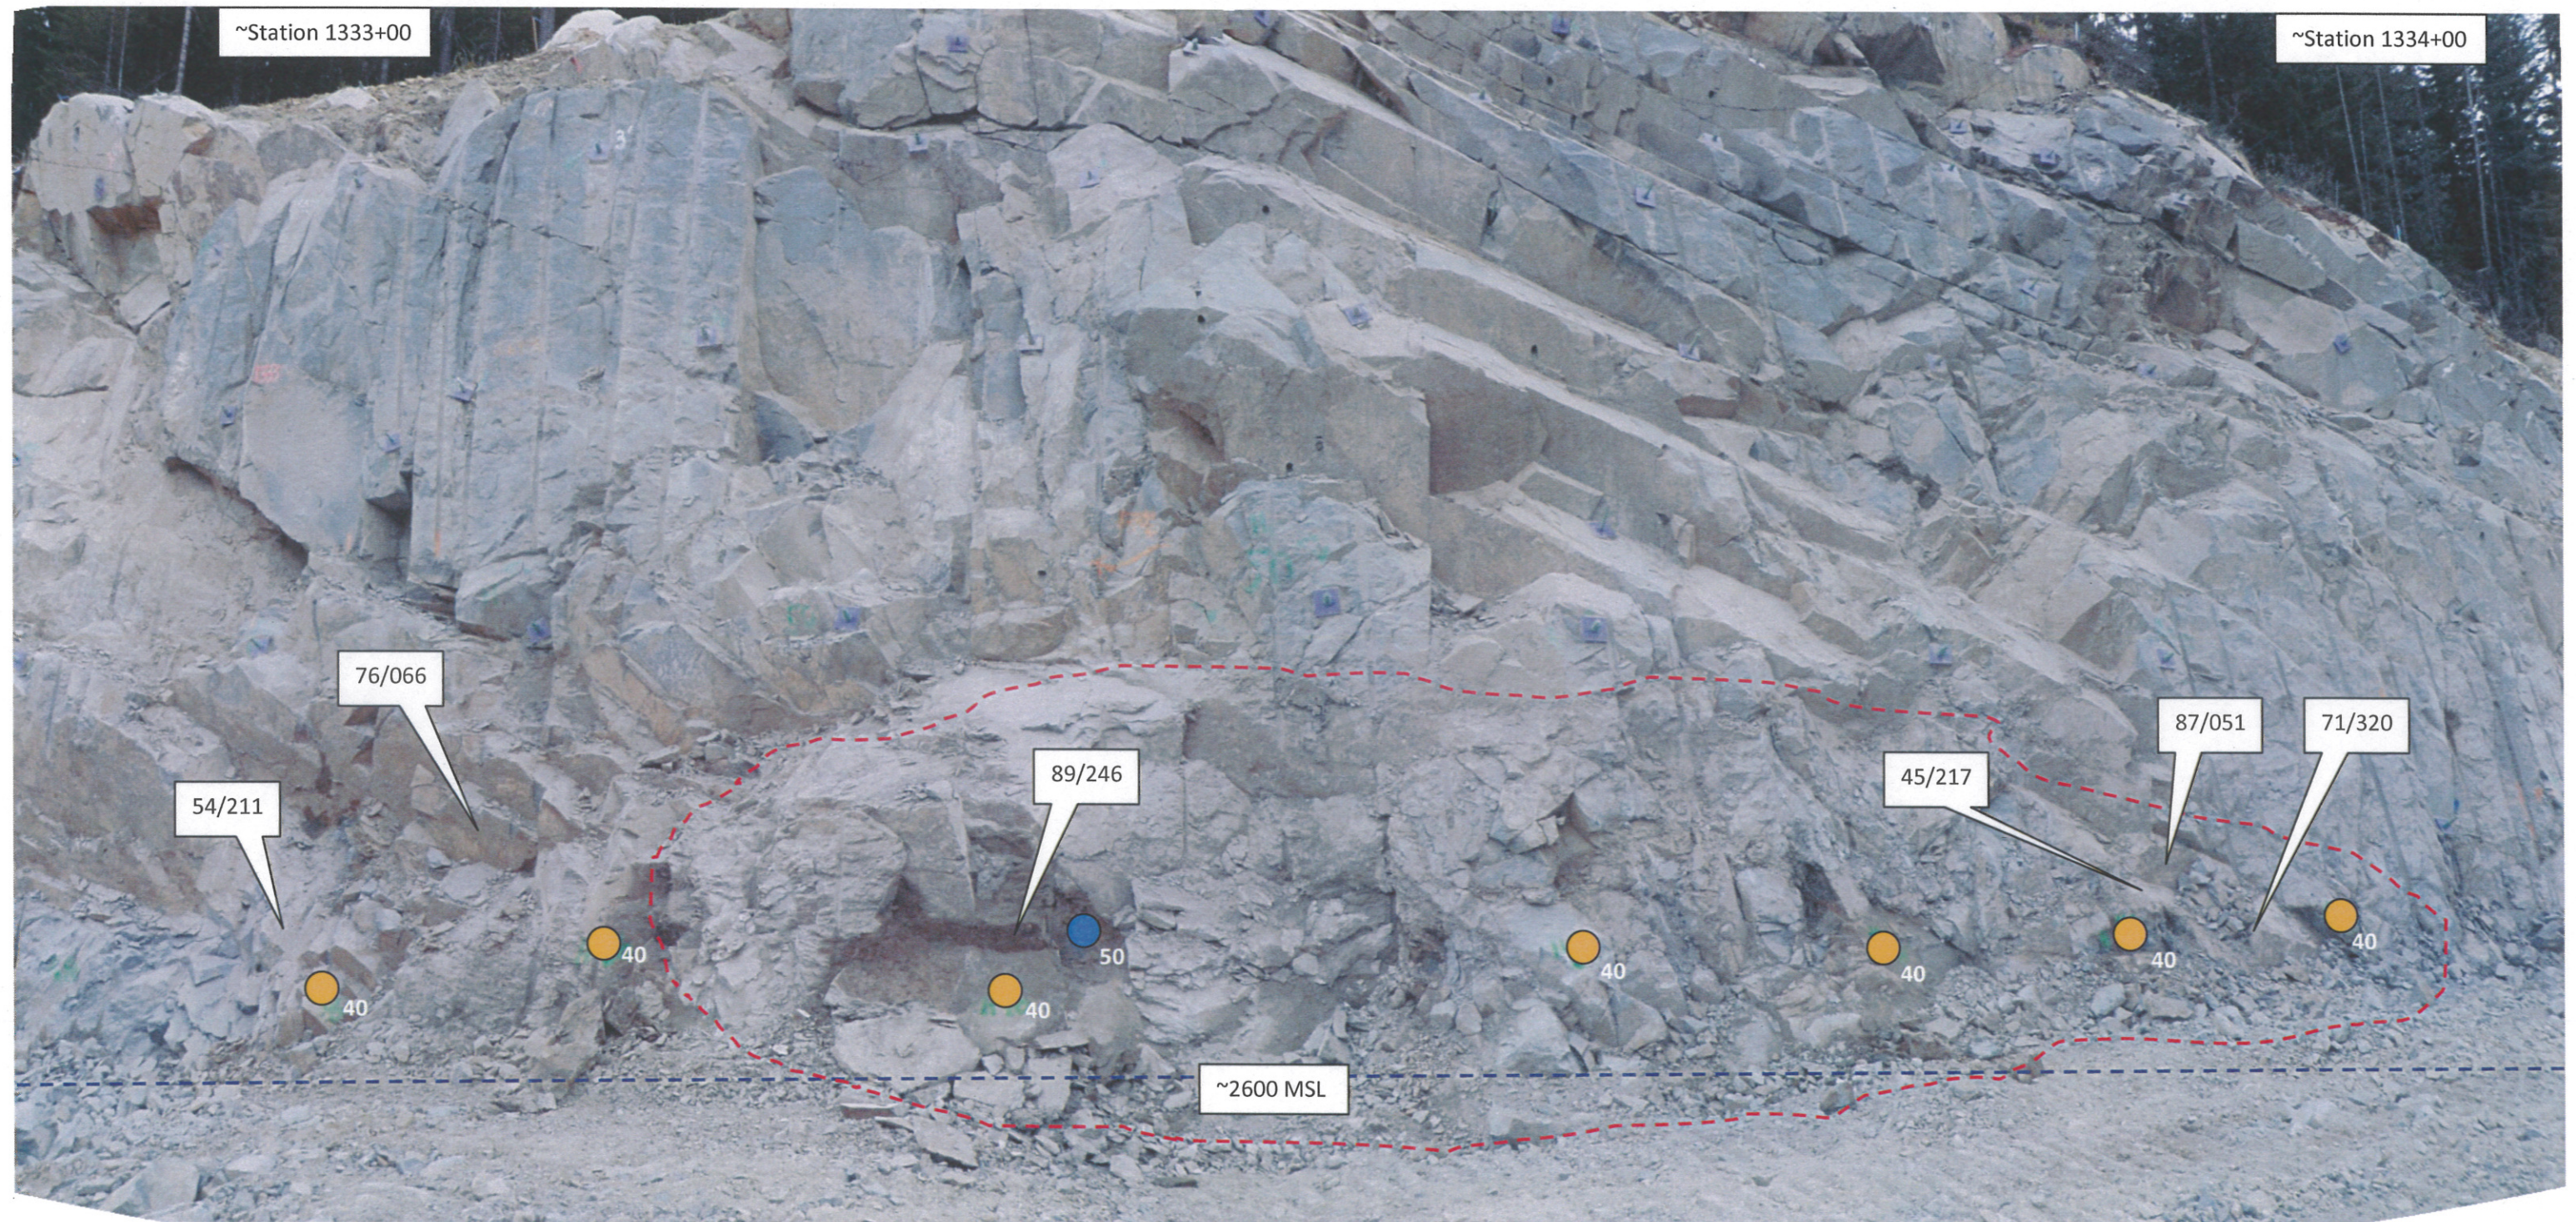
I met Erik Warren on the west end of the project around 7:00 am. We walked to the top of Jenkin's Knob and performed a lift inspection from approximate station 1333+00 to 1334+00 at approximate elevation 2600 MSL. We layed out seven 40-foot type H rock dowels and one horizontal drain (Figure 1). While we were on-site, we had to remove quite a bit of loose rock to spray paint the dowel location. There is still a large area that needs scaling and dressing to be performed (Figure 1).

Figure 1. A photograph showing the lift inspection from approximate station 133+00 to 1334+00 to approximate elevation 2600 MSL.

40 - Type H Rock Dowels (Minimum Length in Feet)

50 - Horizontal Drain (Minimum Length in Feet)

- Scaling and Dressing Location
